**U. S. Army Rotary-Wing  
Emergency Egress Study**

**U.S. Army Aeromedical Research Laboratory  
Fort Rucker, Alabama 36362-0577**

4. PERFORMING ORGANIZATION REPORT NUMBER(S) <b>USAARL Report No. 95-23</b>		5. MONITORING ORGANIZATION REPORT NUMBER(S)	
6a. NAME OF PERFORMING ORGANIZATION U.S. Army Aeromedical Research Laboratory	6b. OFFICE SYMBOL (If applicable) MCMR-UAR-FS	7a. NAME OF MONITORING ORGANIZATION U.S. Army Medical Research and Materiel Command	
6c. ADDRESS (City, State, and ZIP Code) P.O. Box 620577 Fort Rucker, AL 36362-0577		7b. ADDRESS (City, State, and ZIP Code) Fort Detrick Frederick, MD 21702-5012	
8a. NAME OF FUNDING/SPONSORING ORGANIZATION	8b. OFFICE SYMBOL (If applicable)	9. PROCUREMENT INSTRUMENT IDENTIFICATION NUMBER	
8c. ADDRESS (City, State, and ZIP Code)		10. SOURCE OF FUNDING NUMBERS	
		PROGRAM ELEMENT NO.	PROJECT NO.
		TASK NO.	WORK UNIT ACCESSION NO.

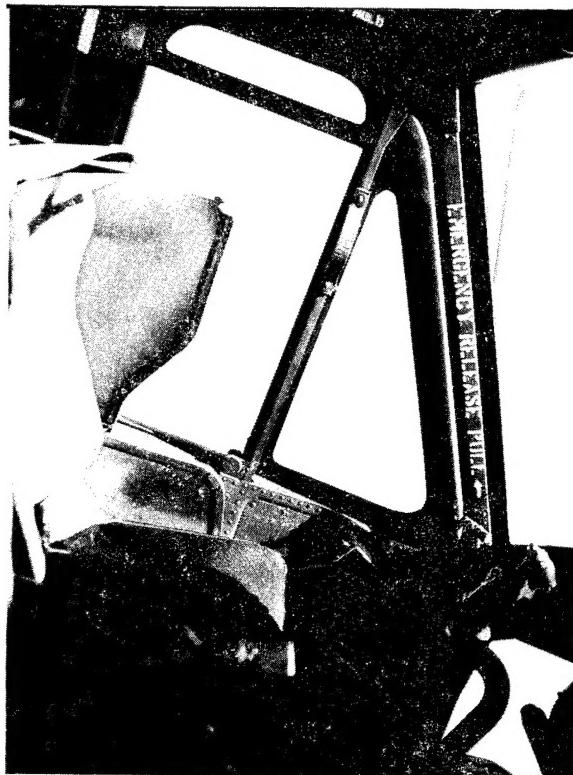
Cockpit --- Emergency exit release handles are located on the front of the cockpit doors, directly above the upper hinge. The T-shaped handles are yellow and black striped. Operating instructions are readable easily and located on the front door frame above the T-handle, as

**Figure 1. UH-1 cockpit area.**

shown in Figures 1 and 2. Pulling the T-handle upwards pulls a cable which releases pins through the door hinges. Once the pins come out, the hinge separates, and the cockpit door is free to fall away. Force required to break the safety and disengage the pins is 25-30 lbs. The door then will fall off by itself or with slight pressure upon it. The opening then is the size of the door frame minus the restric-

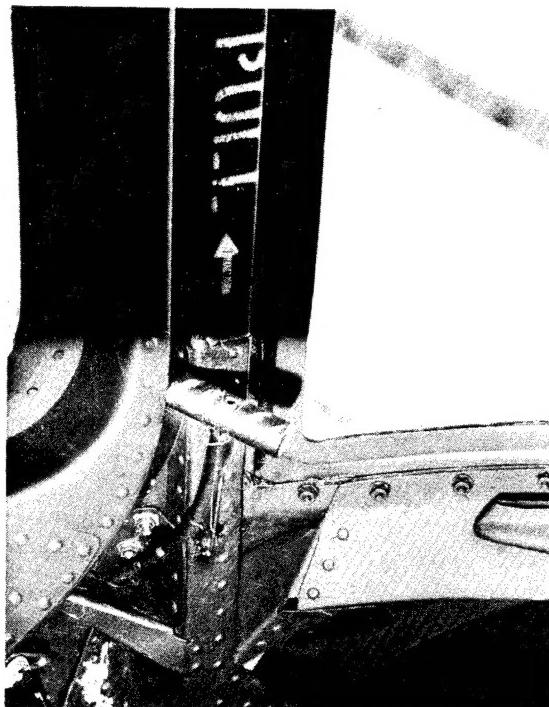
**Figure 2. UH-1 cockpit emergency egress handles.**

tions of the cyclic, armor plate and the collective. The operator's manual displays the emergency exit release handles, but does not have them labeled as seen in the Appendix, Figure 3. Emergency procedures in chapter 9 of the operator's manual are simple and adequate. The cockpit

doors jettison easily and quickly. The armor protection panel on the seat is difficult to slide rearward and takes both hands to operate. With the panel forward, it is difficult to egress and this is the procedure's weak link.

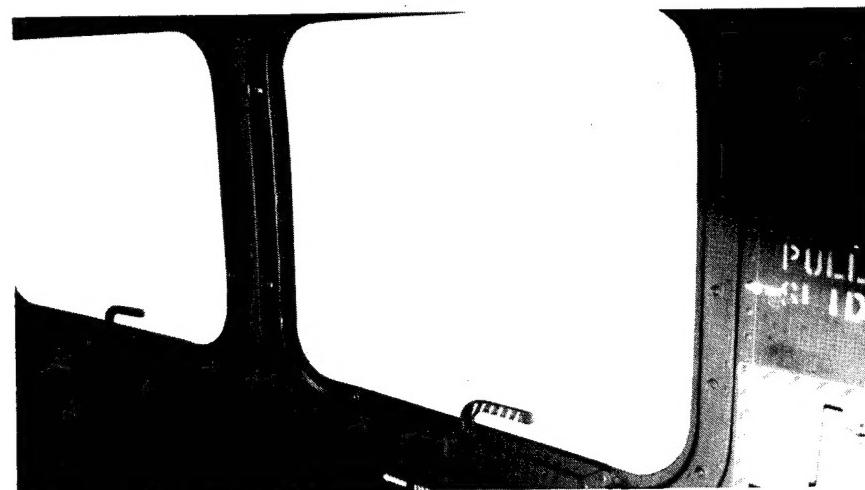
Cabin --- The cabin door window emergency release handles are located at the bottom center of each window. The handles are yellow and black striped. Operating instructions clearly are visible as can be seen in Figures 4 and 5. Lifting up on the handle with 20-25 lbs. of force

retracts stops along the bottom of the window. The bottom of the window then can be pulled inward with minimal force. The top of the window falls free of the frame and the entire window drops into the cabin. It is important to note the window can not be pushed outward, it must pulled inside, and is so noted in the instructions. Then occupants are unrestrained from exiting the aircraft. The operator's manual displays a labeled picture of the exits and handles as seen in the Appendix, Figure 6. Emergency procedures in chapter 9 are simple and adequate.

Figure 5. UH-1 cabin emergency egress handles.

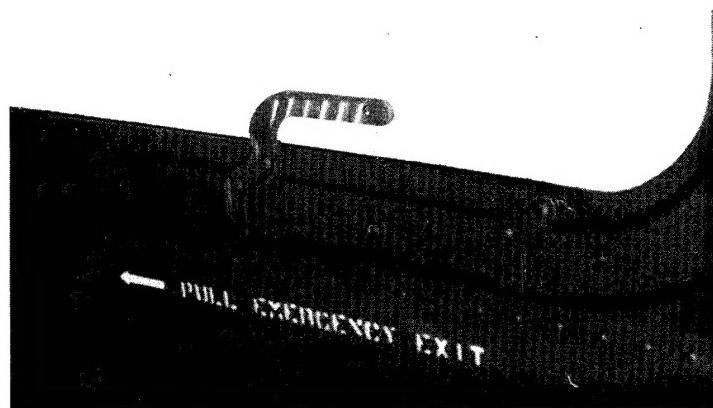
Figure 6. UH-1 cabin emergency exits.

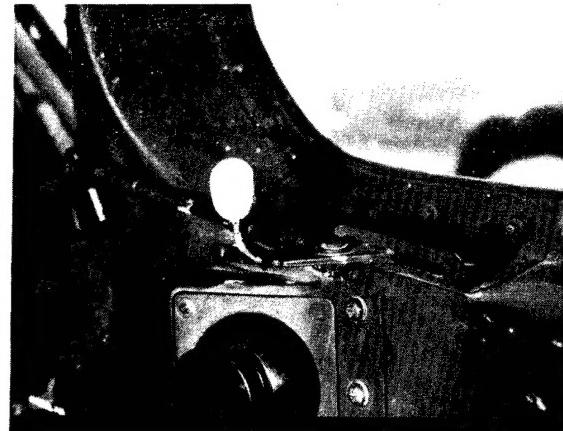
surrounded with ample instructions as shown in Figures 7 through 9. Pulling the emergency handle with 40-45 lbs. of force turns a cam inside the door allowing the door to be separated from the hinge at the mounting points. The operator's manual emergency procedure states the door then may be jettisoned by kicking the lower forward corner. This procedure works; however, on the doors tested, it required *substantial* force to dislodge the door from the hinge. Once the connection is broken, the door falls away from the aircraft. As with the UH-1, the egress is hampered substantially if the protective armor plating has been moved forward. However, unlike the UH-1, the plating on the UH-60 can be moved rearward with only

Figure 7. UH-60 cockpit area.

one hand. The weak link of this procedure is the process of kicking the door away from the hinge.

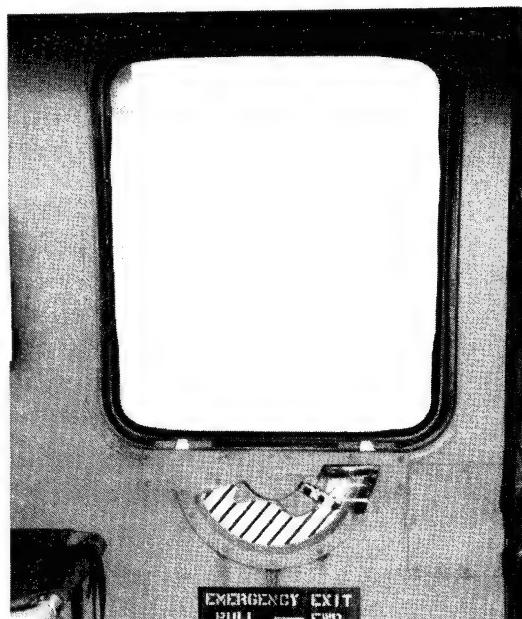
physical difficulties, but it could be confusing under certain circumstances. First under normal egress procedures, passengers seated in the aft area are unable to reach the handle of the cabin door when the system of seating four across the center is used. The doors must be opened by someone sitting in the forward area or from the outside. Second, there is only one cabin door window jettison handle on each cabin door, and they are in different locations on each side. The handles are located under the front window on the left cabin door and under the rear handle on the right side door as shown in Figures 10 and 11. In the Appendix, the cabin's emergency exits can be seen in Figure 12. The locations make it very difficult for passengers in the front area to operate the right side emergency exit, and for passengers in the rear area to jettison the cabin windows on the left side. The direction of handle pull on each side also is different. On the left side the handle is pulled aft and the handle on the right is pulled forward as explained under emergency exits in the operator's manual. On the positive

side of the egress procedure, it takes only approximately 10 lbs. of force to operate the handles and then the windows easily are pushed outward. Pulling the handle releases both the front and the rear cabin door windows on that side.

Figure 10. UH-60 cabin area.

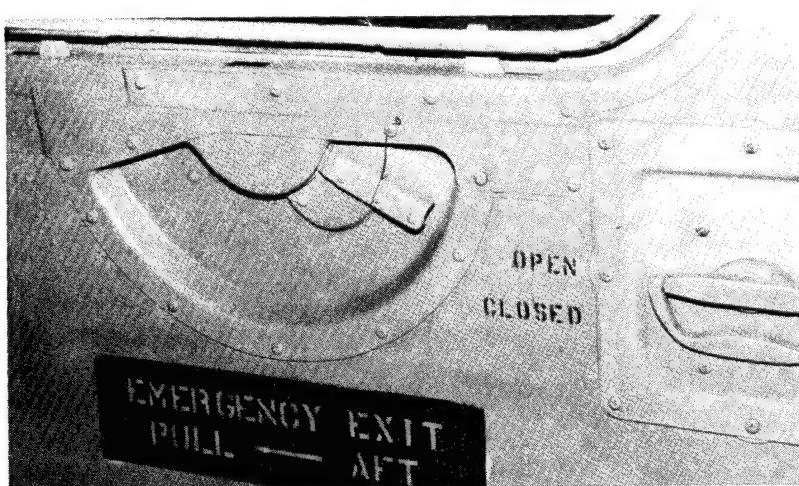
Figure 11. UH-60 cabin emergency egress handles.

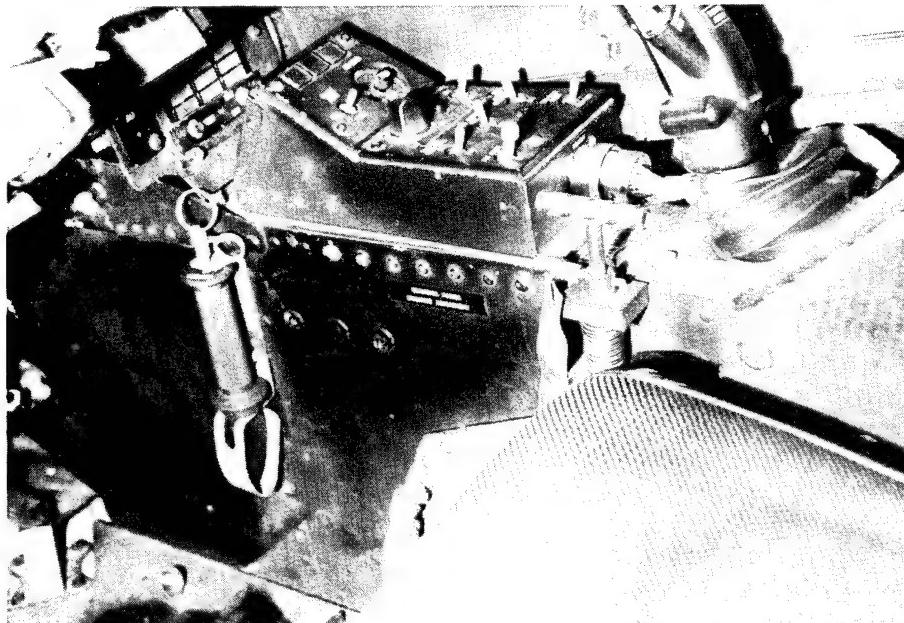
Cockpit only --- The Cobra contains a canopy jettison system that can be operated from either the pilot's rear seat or the copilot/gunner's, (CPG) front seat. The arming/firing mechanisms are located near the instrument panel and have operating instructions on them as shown in Figures 13 through 17. These firing mechanisms are operated by turning the handle 90 degrees counterclockwise with a torque of 6-12 inch-pounds. This maneuver arms

Figure 13. AH-1 copilot/gunner cockpit area.

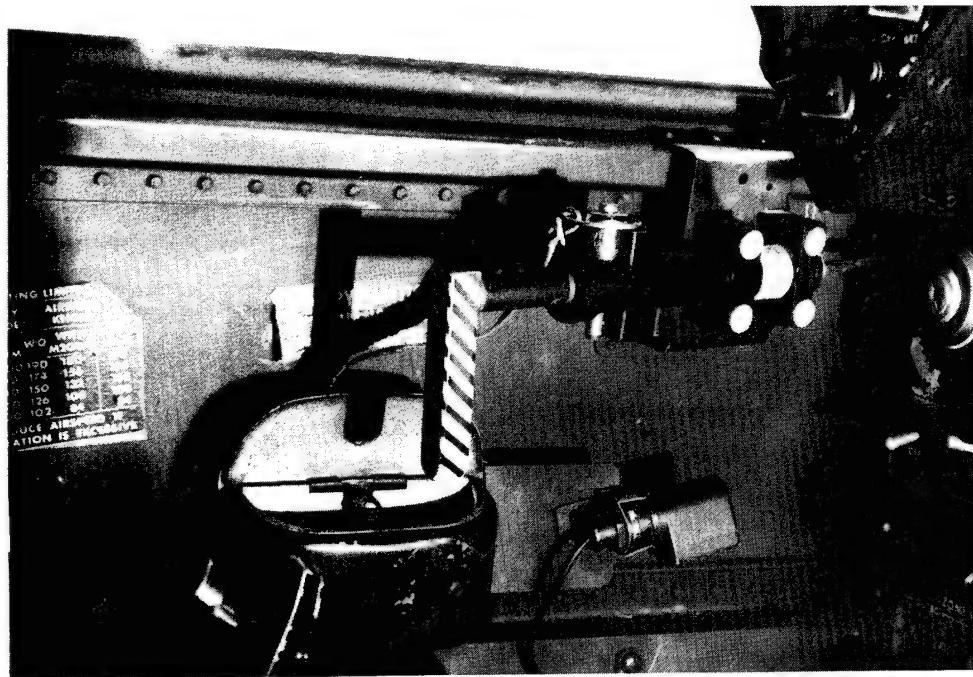
ing them from the fuselage. This system is explained in chapter 2, section II of the operator's manual, but there are no emergency procedure steps outlined in chapter 9. Once the canopy is jettisoned, there is a clear access area for the pilots to egress.

Figure 15. AH-1 pilot cockpit area.

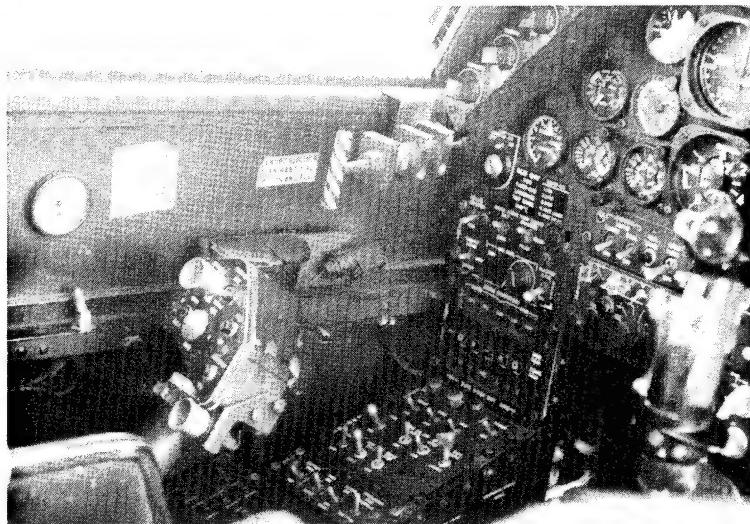
Figure 16. AH-1 pilot emergency egress handle.

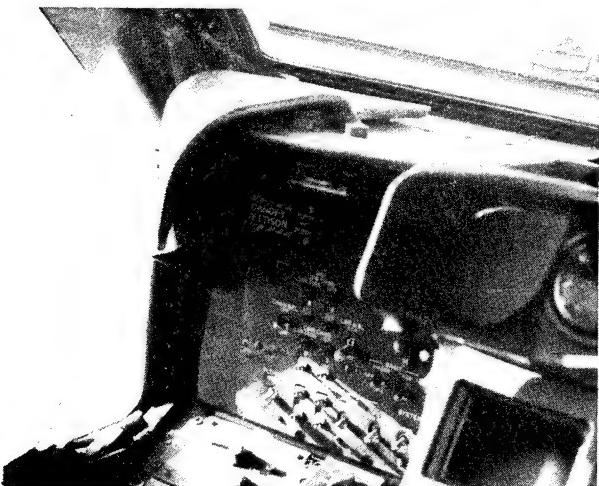
Cockpit only --- The Apache also has a canopy jettison system that expels the four acrylic panels on the sides of the pilot and CPG stations. The Apache however, has three canopy jettison handles. One is on the upper left corner of the pilot's instrument panel. A second is at the upper left corner of the CPG panel. And the third is the external ground crew handle located on the front of the aircraft, under a quick-release panel directly forward of the CPG's windshield as shown in Figures 18 through 23. Like the Cobra, the Apache system is based on an arming/firing handle, a primer/initiator, and a

**Figure 18. AH-64 copilot/gunner cockpit area.**

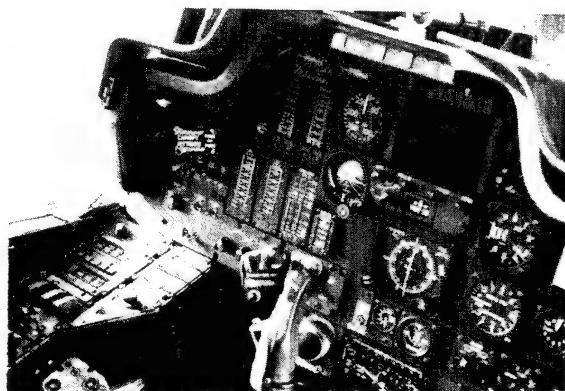
detonation cord around the periphery of the side panels. The operating instructions again are directly on the jettison handles. The system is armed by rotating the canopy jettison handle 90 degrees left or right, which then uncovers the word ARMED on both sides of the handle. The system then is activated by pushing the jettison handle in, detonating the primer/initiator within the handle. The system is explained very well in chapter 2 of the operator's manual. The emergency egress procedures are in chapter 9.

**Figure 20. AH-64 pilot cockpit area.**

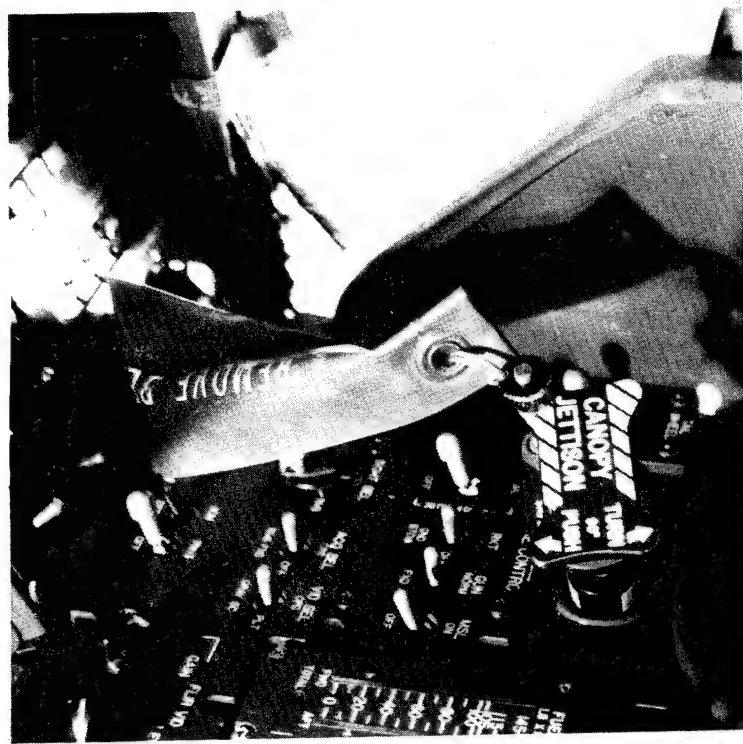
Figure 21. AH-64 pilot emergency egress handle.

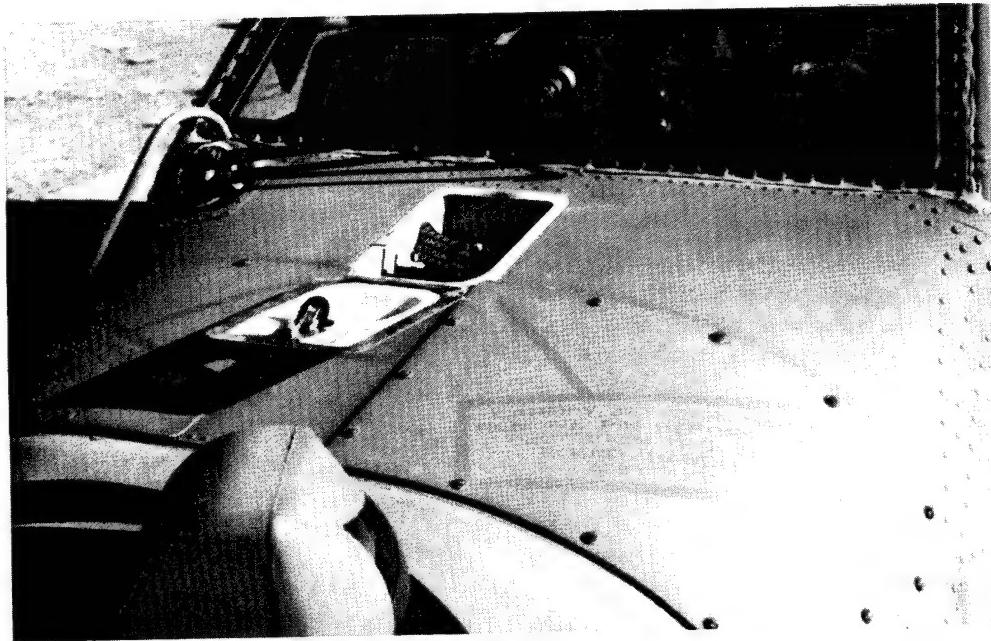
Figure 22. AH-64 ground crew emergency egress handle.

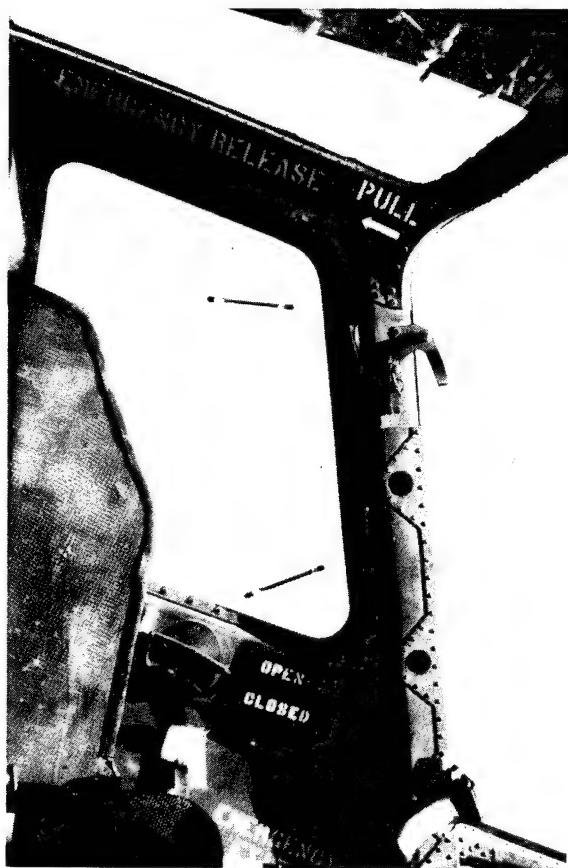
rectly above the emergency exit labels on the door frame as shown in Figures 24 through 26. Pulling aft on the handle with a force of 15-25 lbs. pulls pins on both hinges, allows the hinges to separate, and internal springs then push the door out and away from the aircraft. The handle was difficult to pull aft if there was pressure on the handle towards the center of the cockpit while pulling. We found the end of a mounting bolt restricted the rotation of this lever. This easily was compensated for by applying slight outward pressure on the handle while pulling aft. The armor plating opens easily and quickly

Figure 24. OH-58 cockpit area.

with the outside hand and is not an obstacle while exiting the aircraft. However, if for some reason, i.e., hard landing, the armor should become stuck, the egress area would be reduced substantially. The operator's manual has good figures of the

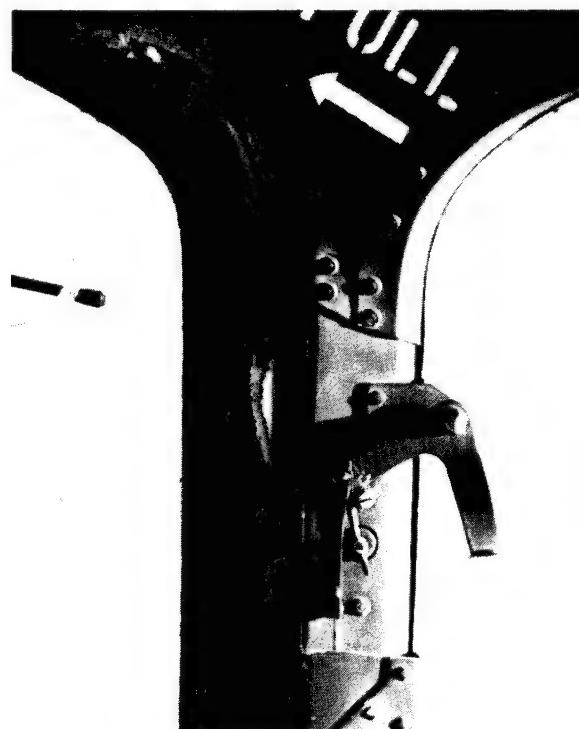
Figure 25. OH-58 cockpit emergency egress handles.

emergency jettison handles and has concise and simple operating instructions in chapter 9. Also, it is important to note in this aircraft the cockpit emergency handles are in a good location to be utilized as hand rests. The operator's manual has a warning in chapter 2 that this may result in inadvertent jettisoning of cockpit doors.

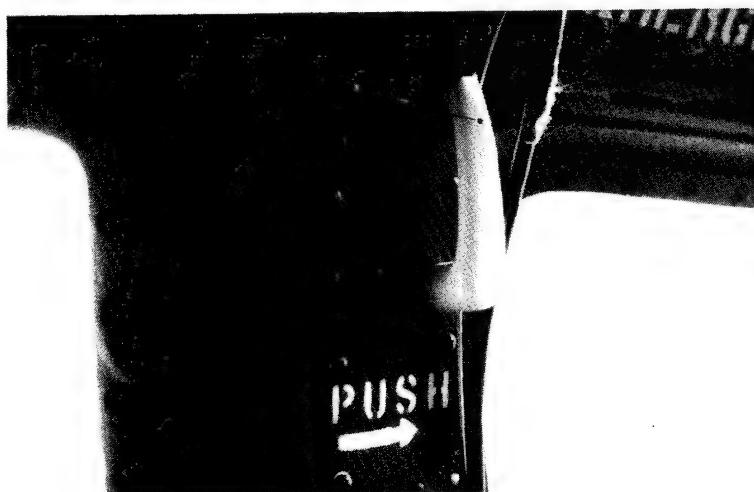
Cabin --- The cabin emergency jettison handles are located on the aircraft frame between the cockpit and cabin doors. The handles are yellow and black striped with instructions on the frame immediately below them as shown in Figures 26 through 28. They operate in a similar fashion and equally as effectively as the cockpit jettison system. The differences is that the cabin handle must be pushed forward and the force required is 25-30 lbs. The door then is easily popped off with the assistance of springs, opening a large egress area. It should be pointed out that if the passenger in the rear is restricted by their inertial reel seat restraint, they may have difficulty reaching the emergency handle because of the distance.

Figure 27. OH-58 cabin emergency egress handles.

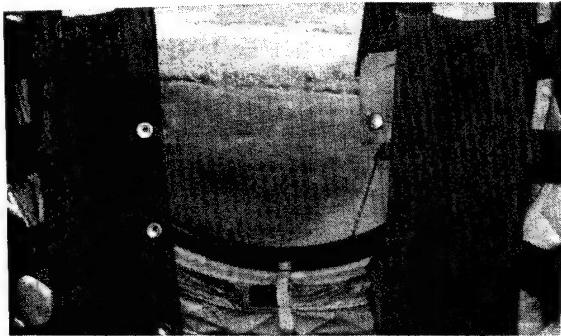
must be taken to prevent accidental jettisoning. The system also may be activated by outside emergency handles located directly below and aft of the cockpit doors. To operate, the handle first must be extended from the aircraft, then turned

Figure 30. CH-47 cockpit emergency egress handles.

while pushing in the trigger button. The instructions for this procedure are painted on the side of the aircraft. When this technique is used, the bottom of the door comes out first. The person operating the exterior handle should be aware of, and avoid the falling door. The force required to turn either handle is between 35 and 40 lbs. With the door off, there is ample room to exit the aircraft. The operator's manual contains ample pictures of the emergency escapes in chapter 9 as shown in Figure 31.

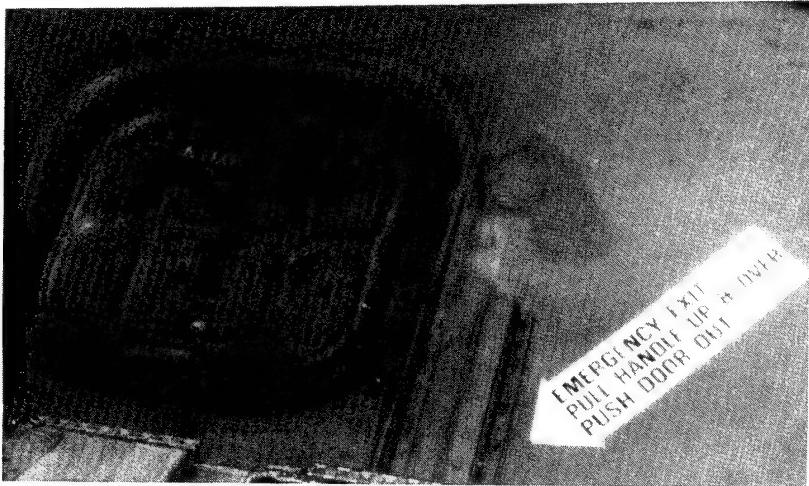
emergency exit on the ramp shell, the shell itself, or exiting through the cargo hook viewing hatch. The windows are jettisoned by pulling a yellow strap hanging from each window as shown in Figure 32. The strap is connected to a seal that runs completely around the window. Pulling the strap away breaks the entire seal and the window then can be pushed out. In addition to the window, a square panel around the window comes out with the front exits on either side, and the exit located on the ramp shell. Adequate instructions for operating these emergency exits are located near the exits and in chapter 9 of the operator's manual as shown in Figures 34 and 35.

**Figure 33. CH-47 cabin area emergency egress ramp.**
